"Your Direct Source for Plant Maintenance, Reliability, Test & Measurement"

Types of Marine Corrosion

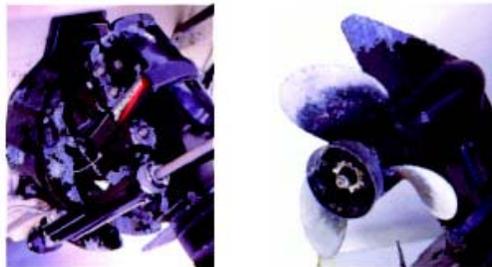
Typical signs of corrosion on marine lower drive units and propellers include blistering paint and the formation of a white powdery substance on the exposed metal areas

The first sign of galvanic corrosion is paint blistering (starting on sharp edges) below the water line—a white powdery substance forms on the exposed metal areas. As the corrosion continues, the exposed metal areas will become deeply pitted, as the metal is actually eaten away.

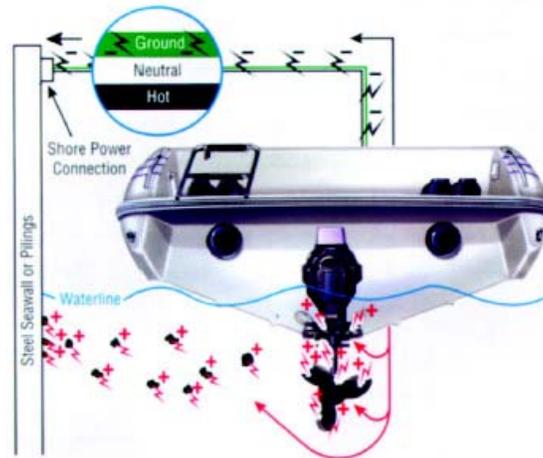
Galvanic corrosion caused by nearby grounded steel structures can occur when you dock your boat and use shore power

Galvanic corrosion can also occur without any stainless steel components on your boat. For example, you have an aluminum drive unit and an aluminum propeller, but you dock at a pier with steel pilings or a steel seawall, then plug into shore power. The ground wire, which is grounded, connects your aluminum components with the submerged steel because the steel is also grounded. Considering the mass of a seawall or even a single piling, your drive and propeller can sustain serious damage. This damage could be prevented with a galvanic isolator.
